Cedar's Silver Lining: Historic Campbell House

CASE STUDY: February 2017

The Certigrade® Cedar Shingle Reroofing Project

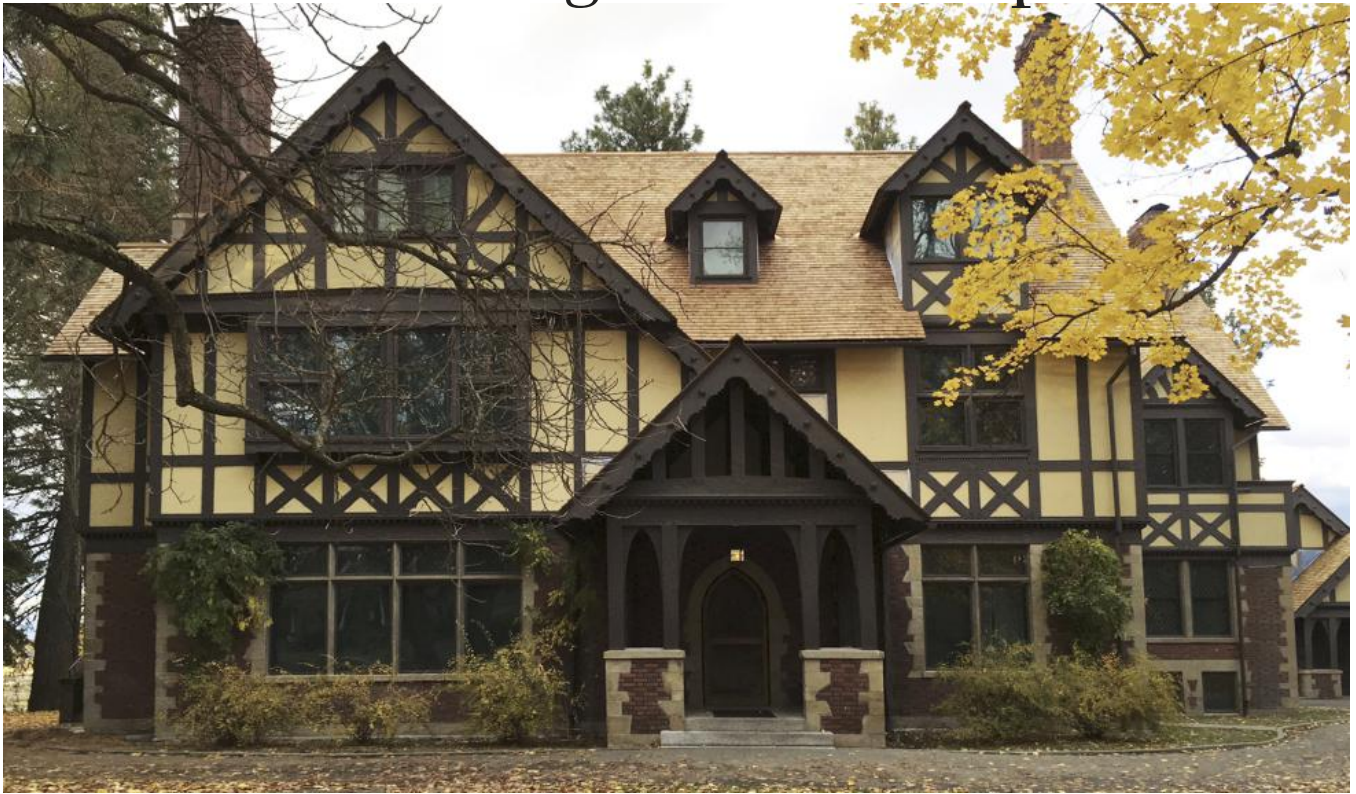
Campbell House Reroof completion, November 2016. Photo courtesy of Northwest Museum of Arts & Culture

The last time that the Tudor Revival-style Campbell House and its carriage house had been reroofed was in 1991. A 2015 roof assessment report, written by **BOLA Architecture + Planning** of Seattle, WA, recommended replacement with **16" Fivex Certigrade® cedar shingles** to match the existing size and exposure. After examining the roof via scissor lift, it was noted that debris had built up in keyways and at the first course, reducing the lifespan of the roofs. Observations from the attic spaces revealed solid board sheathing on the main house, and skip sheathing on the carriage house, with insulation in the rafter spaces. Both structures needed better ventilation systems to improve air flow. **Matt Hamel, AIA, LEED AP BD+C, Associate with BOLA Architecture + Planning ("BOLA")**, noted that the firm's recommendations "tried to keep as close to the historic details and configurations as possible." **Hamel** contacted **Tony Bonura**, CSSB District Manager, Northeast, for technical assistance with this project. The CSSB's New Roof Construction Manual was also consulted as a useful guide.

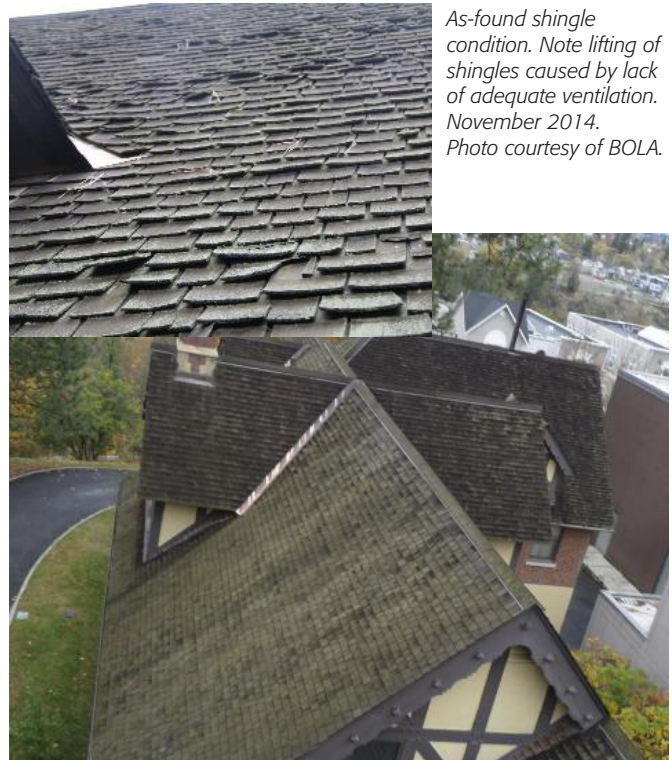
As-found shingle condition. Note lifting of shingles caused by lack of adequate ventilation. November 2014. Photo courtesy of BOLA.

The existing roofs had two distinct substrate systems: solid sheathing with roofing felt at the main house, and skip sheathing with no felt at the carriage house, which resulted in more deterioration and cupping on the unvented main house. The 2016 reroof project incorporated a non-permeable membrane protection at the eaves, valleys, rakes and sidewalls. Specifications also called for 30lb felt underlayment with ASTM D226 type II specification. **Cedar Breather®** continuous ventilation product and **Ridge Vent®** materials were installed for ventilation purposes. Double coated copper flashings were used

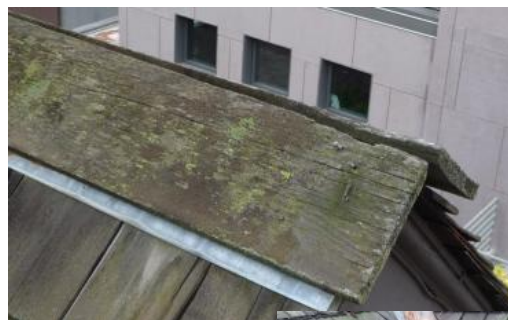
Carriage House ridge cap with mitered, open joint and rusting flashing, November 2014. Photo courtesy of BOLA.

The existing ridge cap boards were thin, with short nails, and detailed with a mitered joint on the Carriage House, which were open at various places. The ridges also had rusting cap flashing, which projected about an inch below the ridge boards. An improved detail was developed with slightly thicker, fire-retardant treated material, a lap joint, longer nails to penetrate the sheathing, copper flashing, and **Rapid Ridge®** ridge vent.

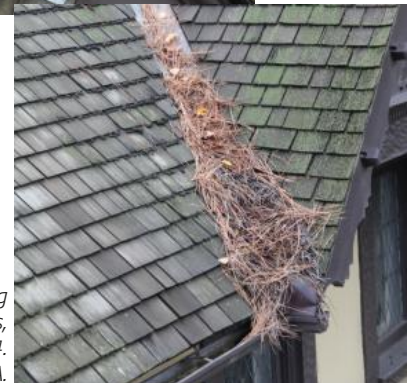
Valley with copper flashing and tree debris, November 2014. Photo courtesy of BOLA.

throughout, making for an elegant finishing touch at the multitude of dormer valleys, ridges, and chimney flashings. Wider valleys were specified for the 1991 and 2016 reroofing jobs, as the 1898 valley widths were only 2 inches on either side, making for debris clogging conditions. Other specially-made copper flashing components and fully-soldered joints were critical to the finished work. Type 316 stainless steel fasteners were used throughout.

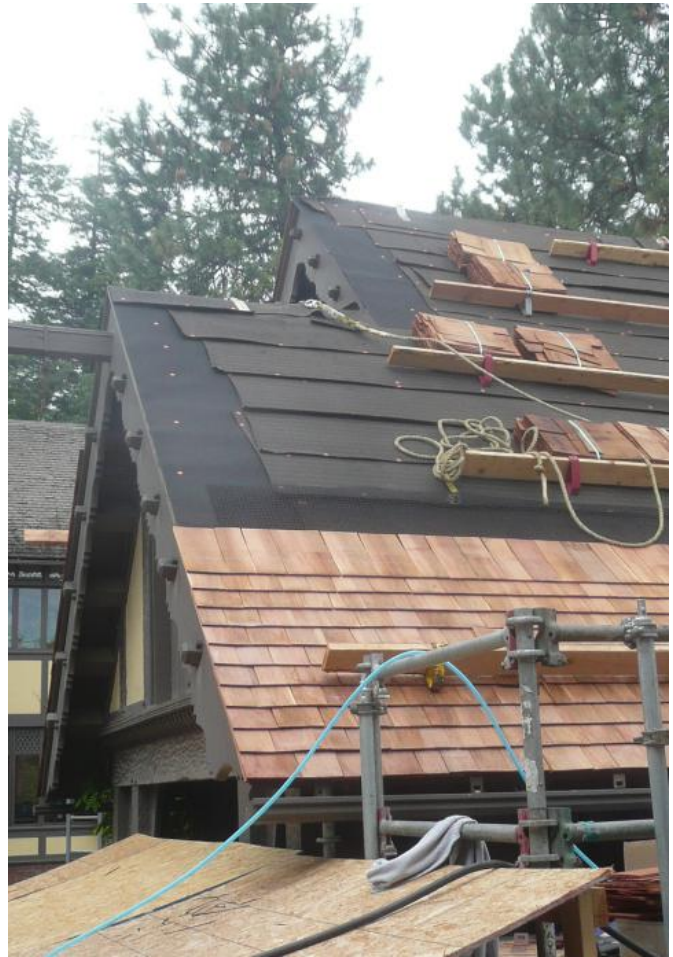
*Carriage House with 5" exposure shingles, July 2016.
Photo courtesy of BOLA.*

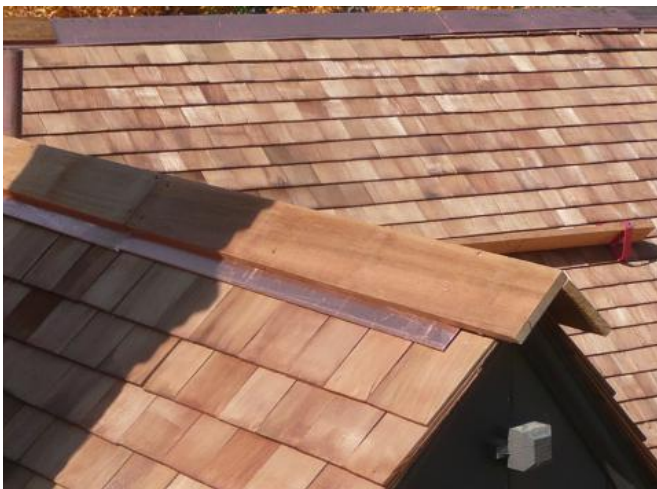
*Detail of improved ridge cap. September 2016.
Photo courtesy of BOLA.*

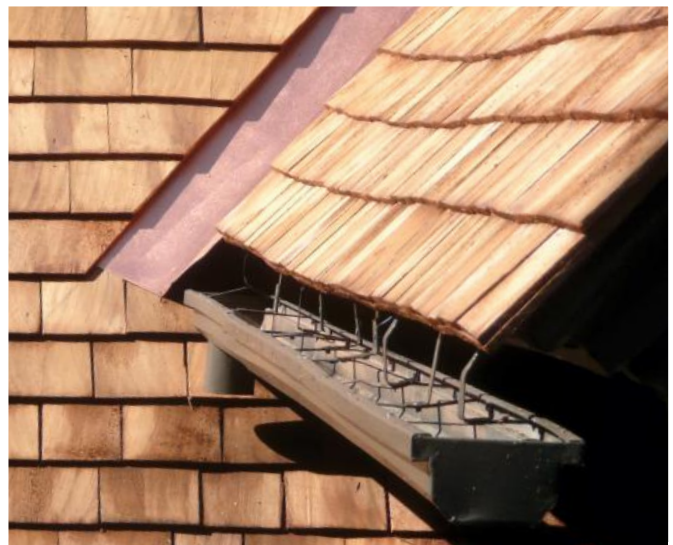
Work included restoring, re-leveling, and re-aligning the drip line of the existing custom shaped and custom hung gutters and downspouts. September 2016. Photo courtesy of BOLA.

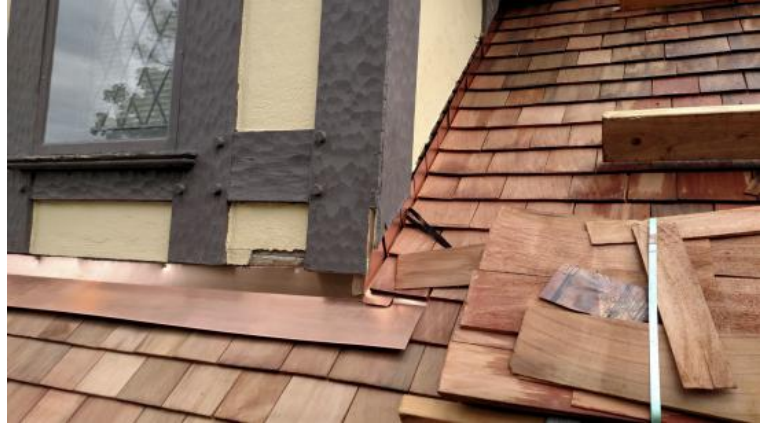
Carriage House dormer, showing step flashing integration with existing base flashing, and adzed trim to be restored, July 2016. Photo courtesy of BCI.

The reroofing job began in June 2016. **Darrell Kidwell, VP with All Surface Roofing & Waterproofing, Inc.**, noted that "... as is typical with old buildings, there were some additional sealant and plaster deterioration issues." Vertical wood trim deterioration was also discovered, and repaired with epoxy wood restoration products, and new wood to match the existing where elements were beyond repair. Local craftsman **Joe Mitchell of Inland Millworks** met the craftsmanship challenge, creating new trim to match the 1898 scalloped surface – itself a simulation of English Tudor construction with a tool called an adze, best described in laymen's terms as a scooped hatchet. One final challenge was getting the special board-length ridge caps fire-retardant treated to match the rest of the roof. The treatment process limited lengths to six to eight feet.

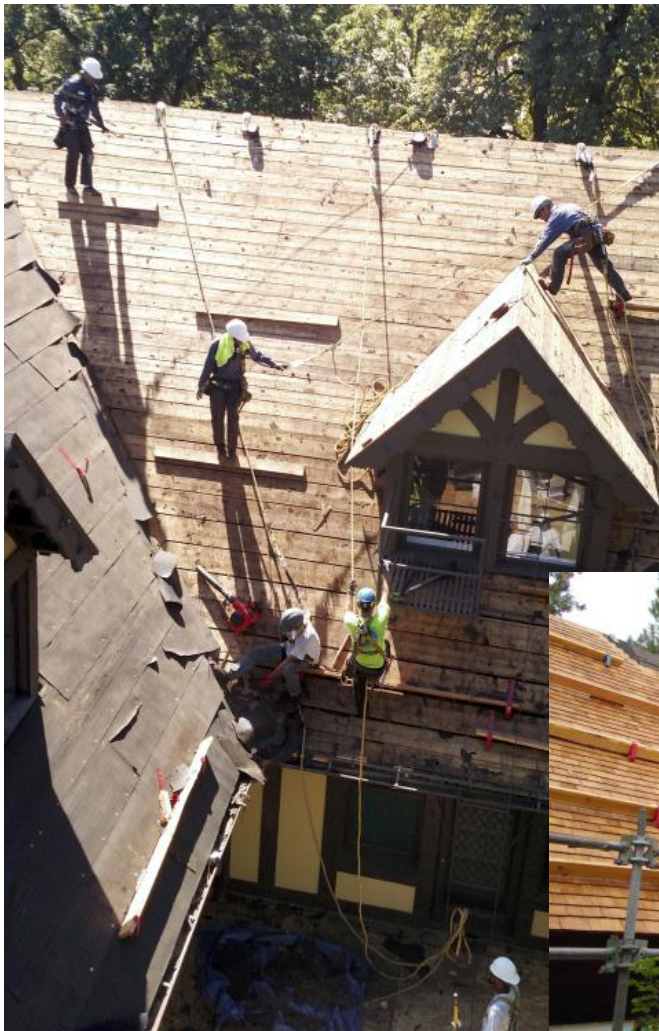
Campbell House during tear-off and sheathing evaluation, showing tight sheathing, August 2016. Photo courtesy of BCI.

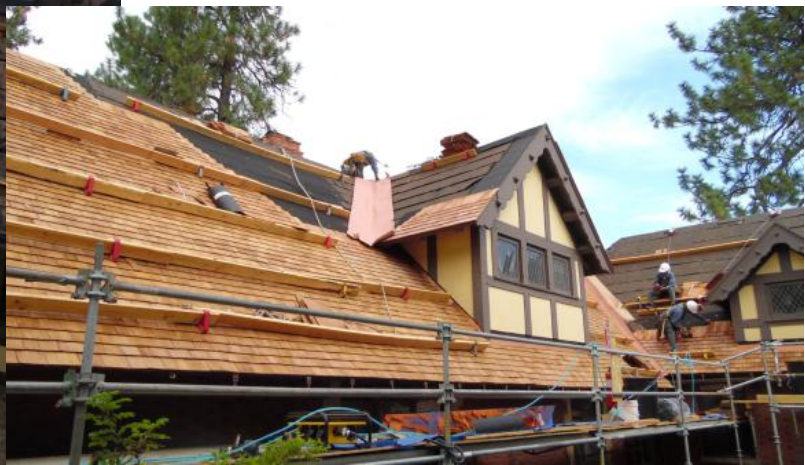
Reroofing the carriage house in 2016. Photo courtesy Tony Hyatt, Cedar Shake and Shingle Bureau.
