Campbell House

Historic Cedar Shingle Reroof in Spokane, Washington

by Lynne Christensen, director of operations, Cedar Shake & Shingle Bureau

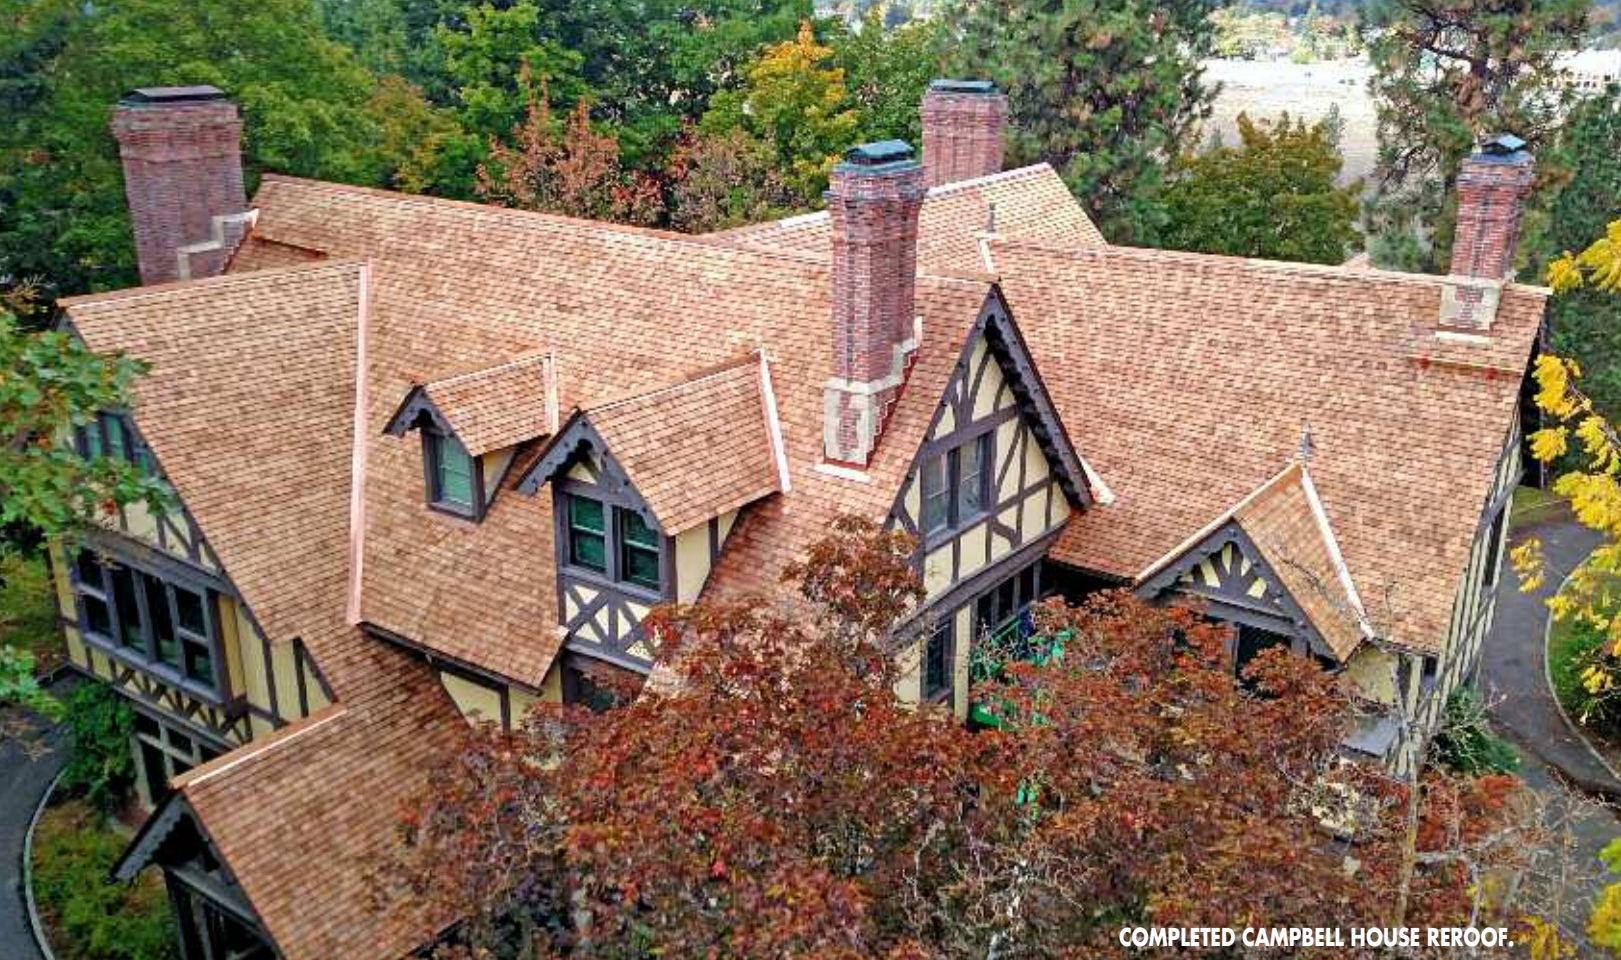
COMPLETED CAMPBELL HOUSE REROOF.

with no felt at the carriage house, which resulted in more deterioration and cupping on the unvented main house. The 2016 reroof project incorporated a non-permeable membrane protection at the eaves, valleys, rakes, and sidewalls. Cedar Breather® continuous ventilation product and Ridge Vent® materials were installed for ventilation purposes. Double-coated copper flashings were used throughout, making for an elegant finishing touch at the multitude of dormer valleys, ridges, and chimney flashings. Wider valleys were specified for the 1991 and 2016 reroofing jobs, as the 1898 valley widths were only 2" on either side, making for debris-clogging conditions. Other specially-made copper flashing components and fully-soldered joints were critical to the finished work.

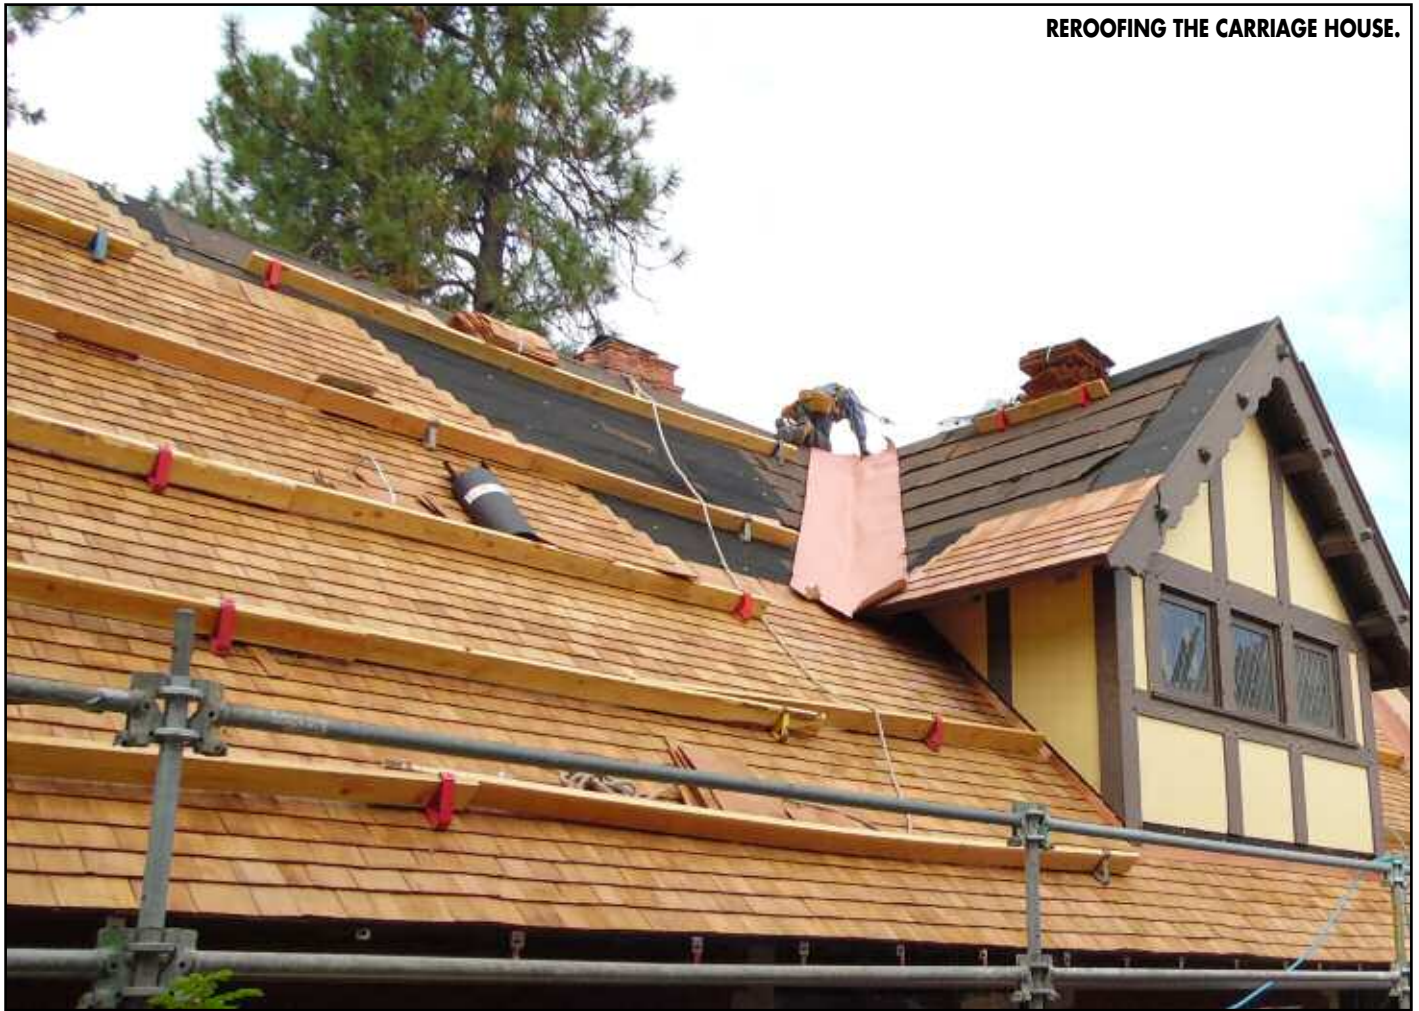
REROOFING THE CARRIAGE HOUSE.

The existing roofs had two distinct substrate systems: solid sheathing with roofing felt at the main house, and skip sheathing

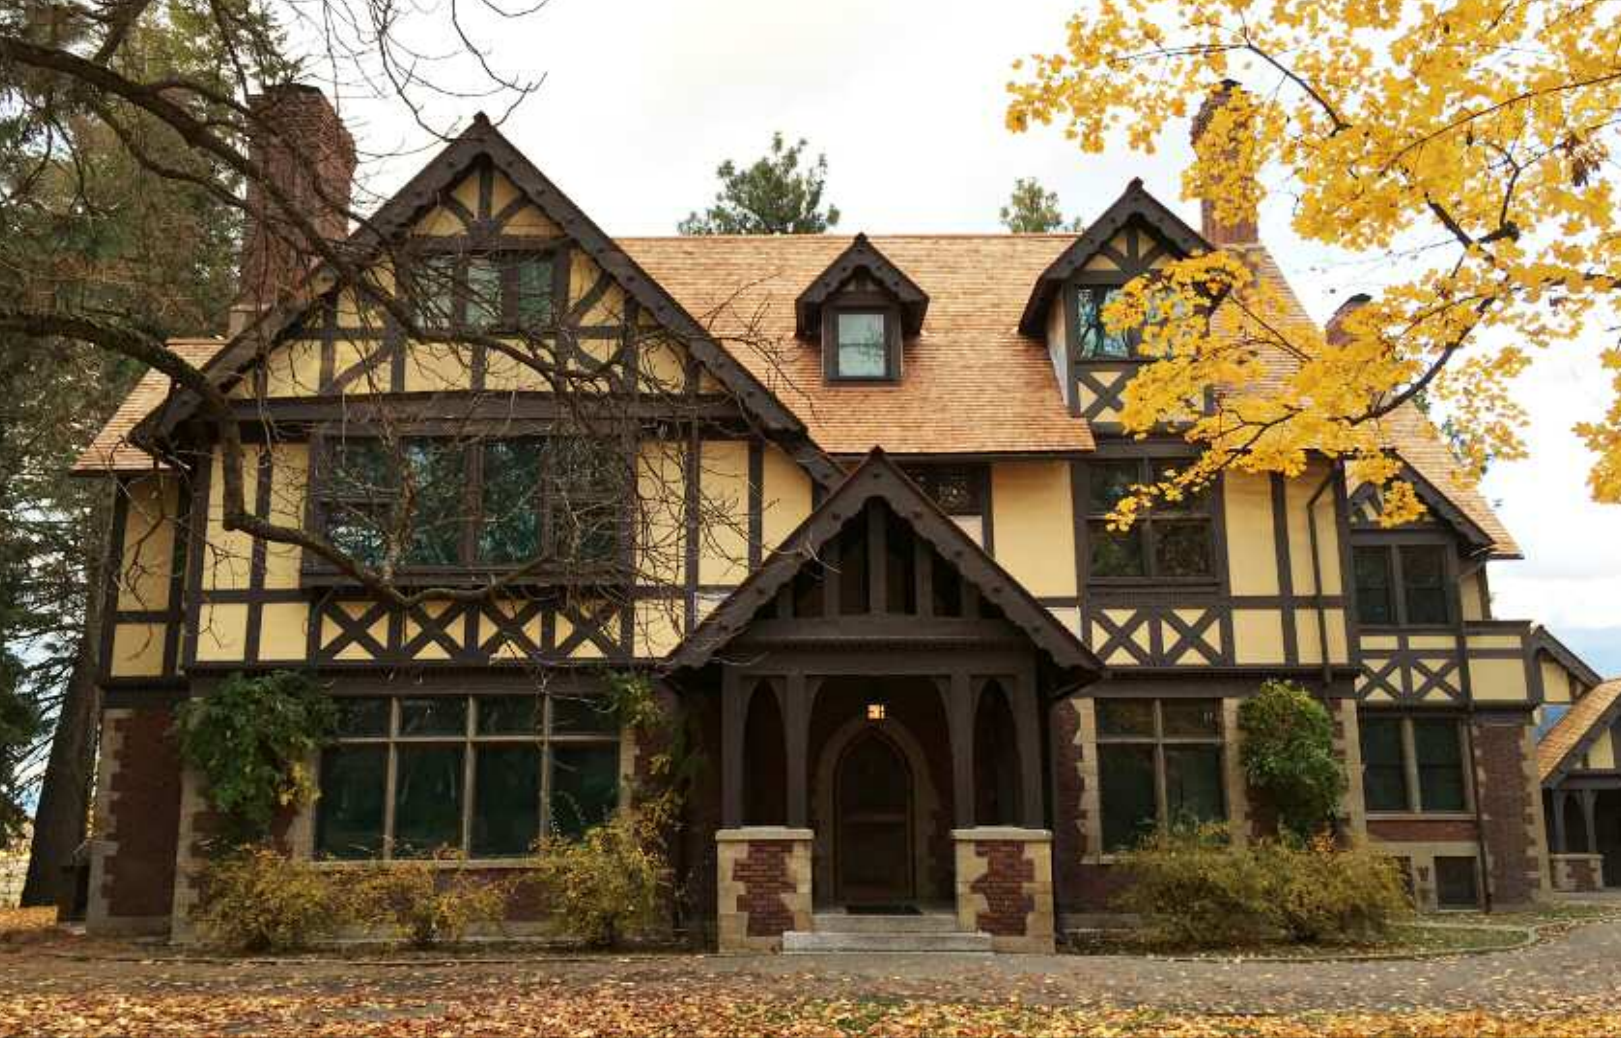
Campbell House

The reroofing job began in June 2016. Darrell Kidwell, VP with All Surface Roofing & Waterproofing, Inc., noted, "As is typical with old buildings, there were some additional sealant and plaster deterioration issues." Vertical wood trim deterioration was also discovered and repaired with epoxy wood restoration products and new wood was used to match the existing wood

where elements were beyond repair. Local craftsman Joe Mitchell of Inland Millworks, Spokane Valley, Washington, met the craftsmanship challenge, creating new trim to match the 1898 scalloped surface. One final challenge was getting the special board-length ridge caps fire-retardant treated to match the rest of the roof.
