Reroofing An Illinois Legend: Certi-label™ Cedar Shakes

Case Study: June 2012

A Large Reroofing Project

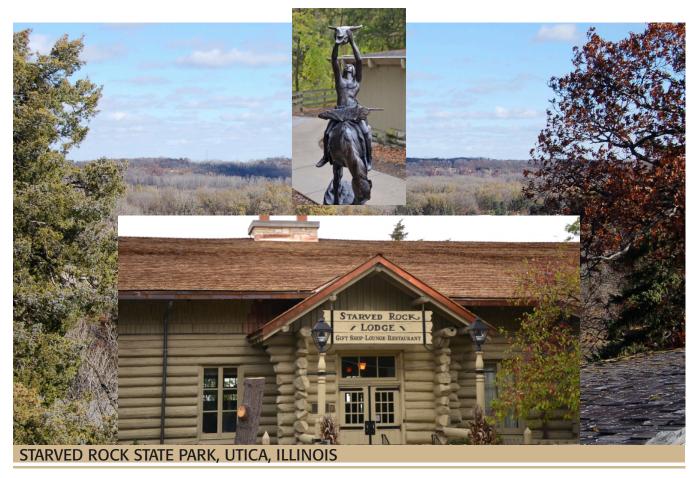
The roof prior to the new installation.

100 years of history translates into a need for periodic renovations and upgrades. A professional roof evaluation was conducted by **Thomas W. Hutchinson**, AIA, FRCI, RRC, CSI, and concluded that the 18,145 ft² or 181 square cedar roof system needed to be replaced after 26 years of faithful service. **The Capital Development Board (CDB)** was responsible for selecting the architect and specifying the details of the new cedar roof project, within official parameters. Attention to historical accuracy was very important; archive photos were used to guide the material selection and design of this significant project.

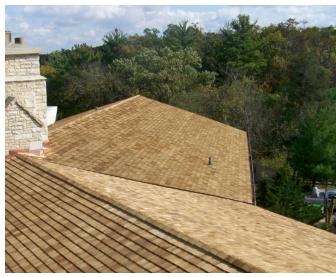
A large finished field section of the roof.
