WEATHERED VERSUS NEW

NATURAL AND CERTI-LAST® PRODUCTS

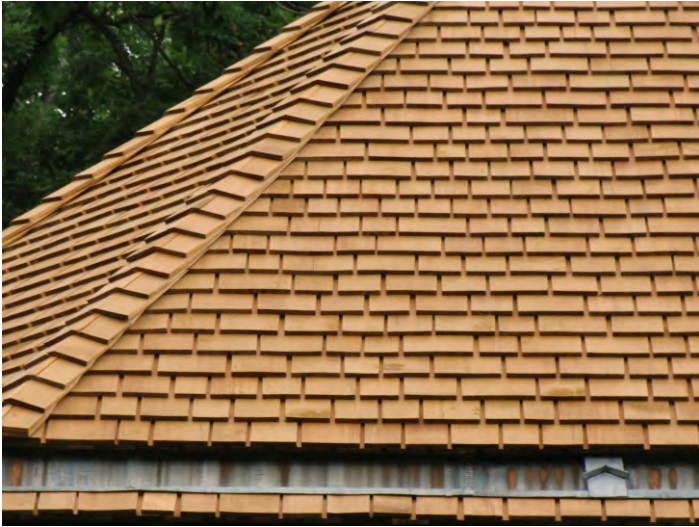
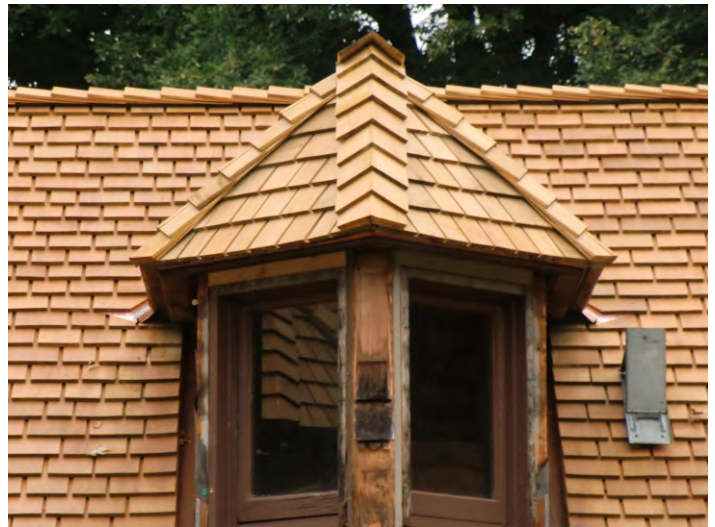
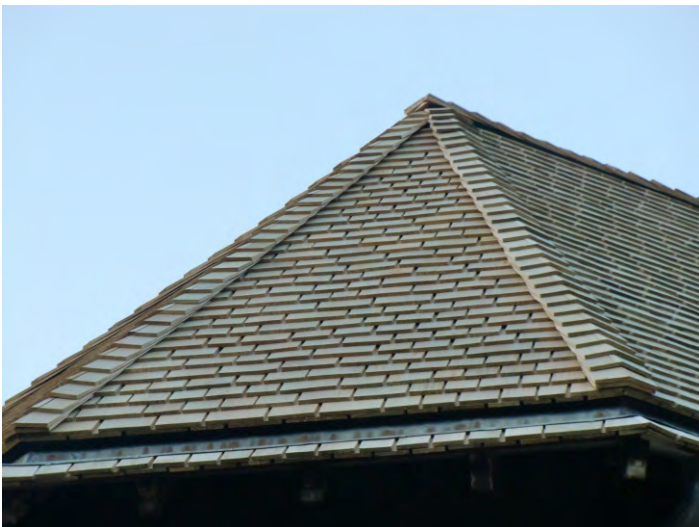
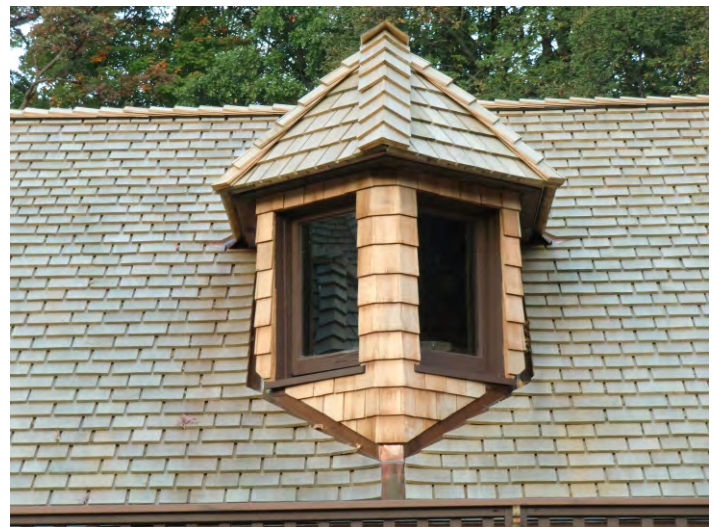
Certi-Last® Yellow Cedar Shakes 18" x 5/8", Premium Grade

Top photographs: 8/14/15 Bottom Photographs: 10/20/15 Certi-Last®, Northeast United States

The examples shown have no finish, stain or weathering product applied; the photographs all show the natural factors that influence weathering are:

1. Exposure to U/V; the latitude of the structure and micro-climates have an effect on weathering
2. How long is the wood being exposed to the sun (U/V); Position of the wood relative to the angle of the sun, the design of the structure, man-made & natural obstructions

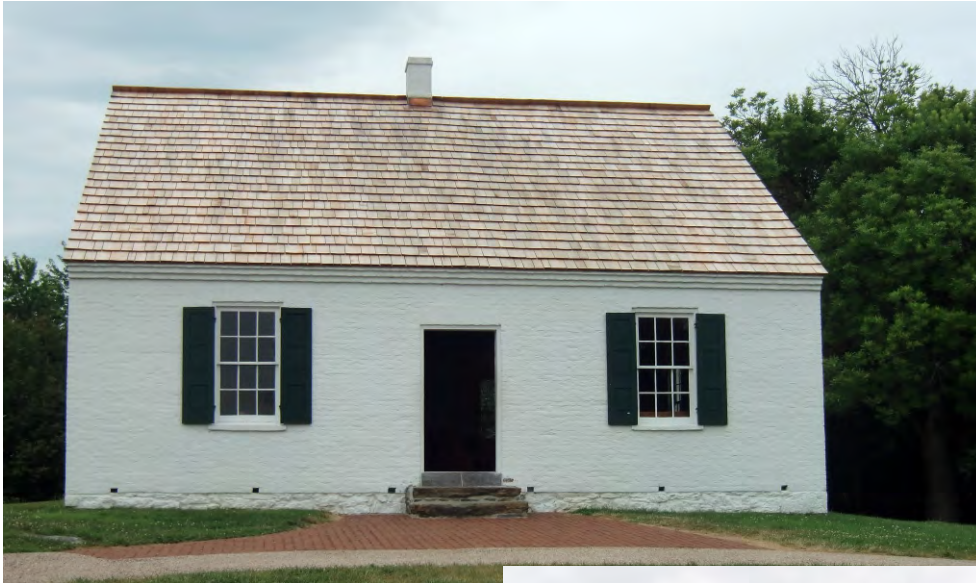
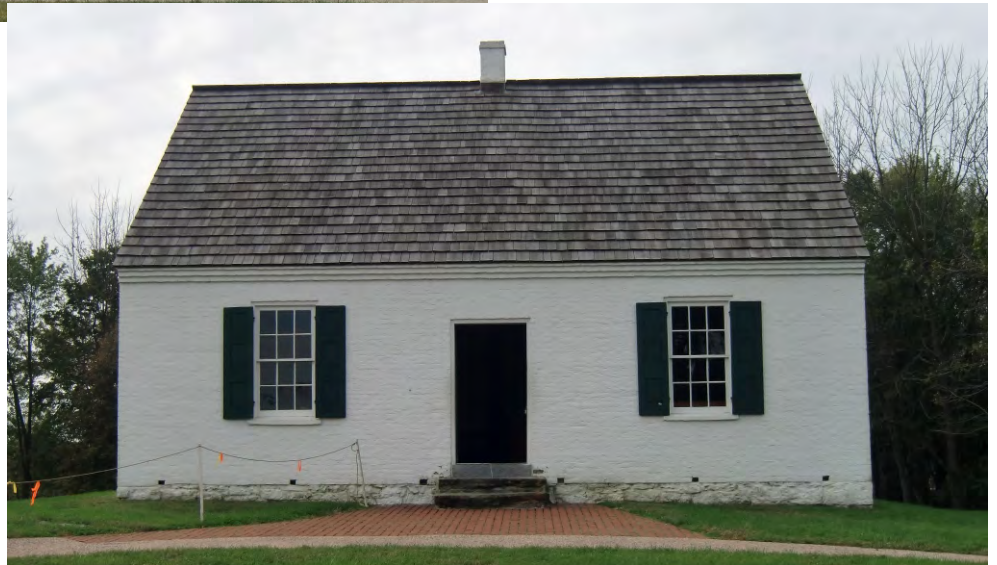
Certigrade®, Western Red Cedar 24" Royal Shingles, Number 1 Grade

Top photograph: 7/26/16 Bottom photograph: 10/16/16 Natural/Untreated, Mid-Atlantic United States

The examples shown have no finish, stain or weathering product applied; the photographs all show the natural factors that influence weathering are:

1. Exposure to U/V; the latitude of the structure and micro-climates have an effect on weathering
2. How long is the wood being exposed to the sun (U/V); Position of the wood relative to the angle of the sun, the design of the structure, man-made & natural obstructions

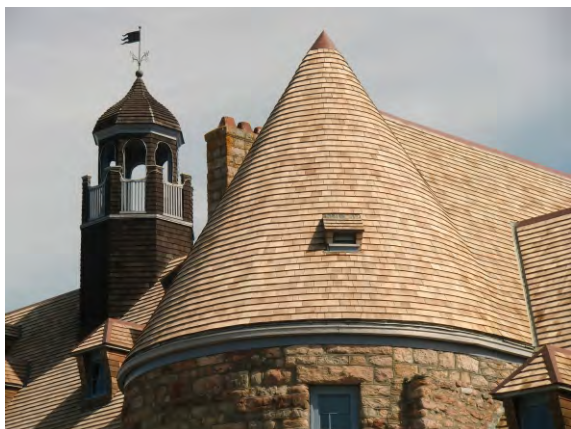
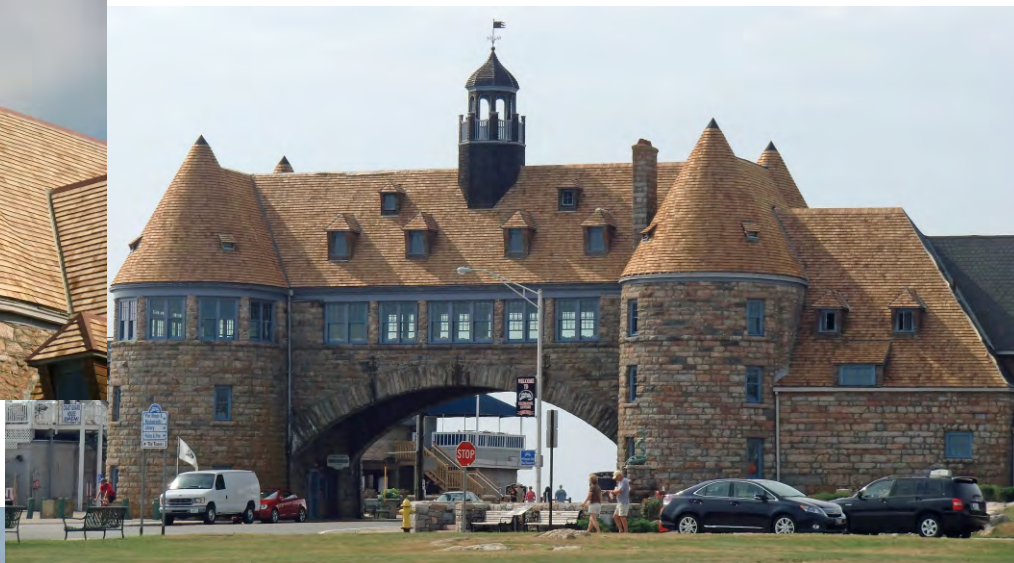
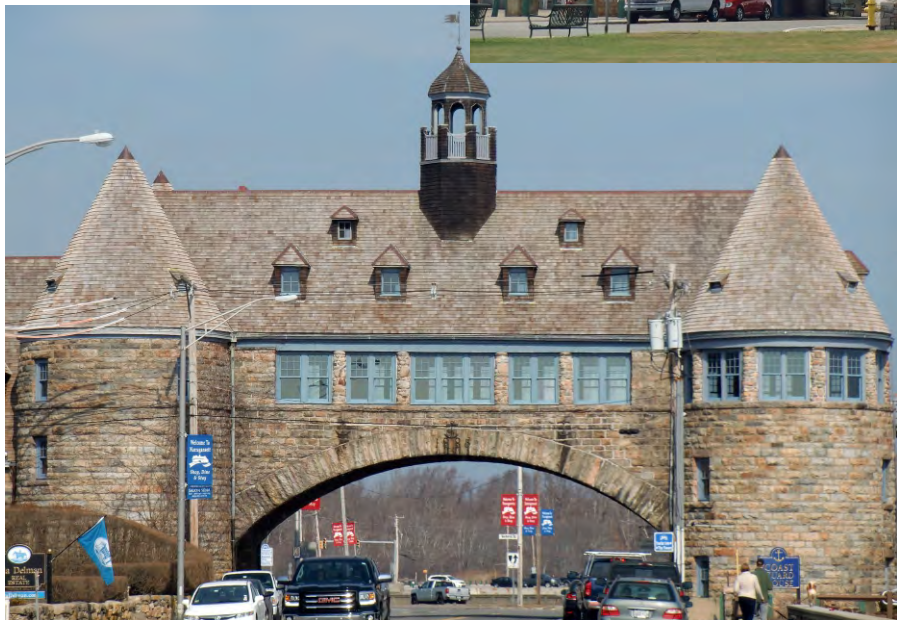
Certi-Last® Western Red Cedar Shakes 5/8" X 18", Premium Grade

Top-left photograph: 4/21/14 Middle photograph: 7/22/13 Bottom photograph: 3/8/16 Certi-Last®, Northeast United States

The examples shown have no finish, stain or weathering product applied; the photographs all show the natural factors that influence weathering are:

1. Exposure to U/V; the latitude of the structure and micro-climates have an effect on weathering
2. How long is the wood being exposed to the sun (U/V); Position of the wood relative to the angle of the sun, the design of the structure, man-made & natural obstructions

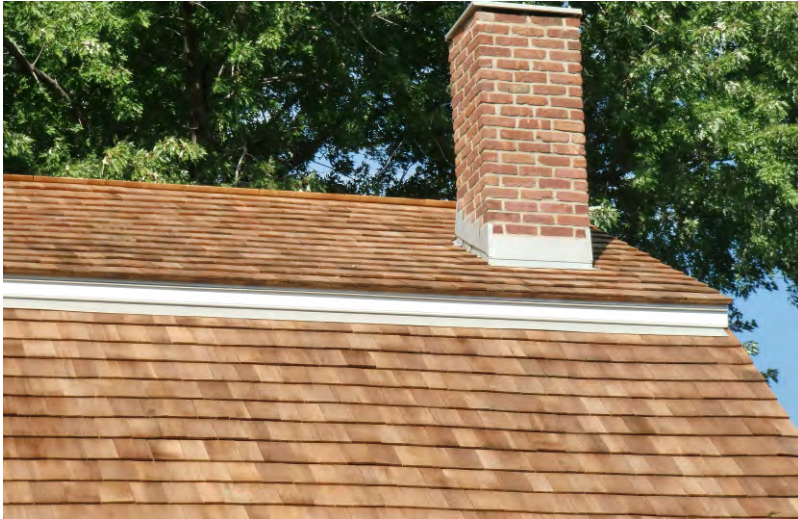
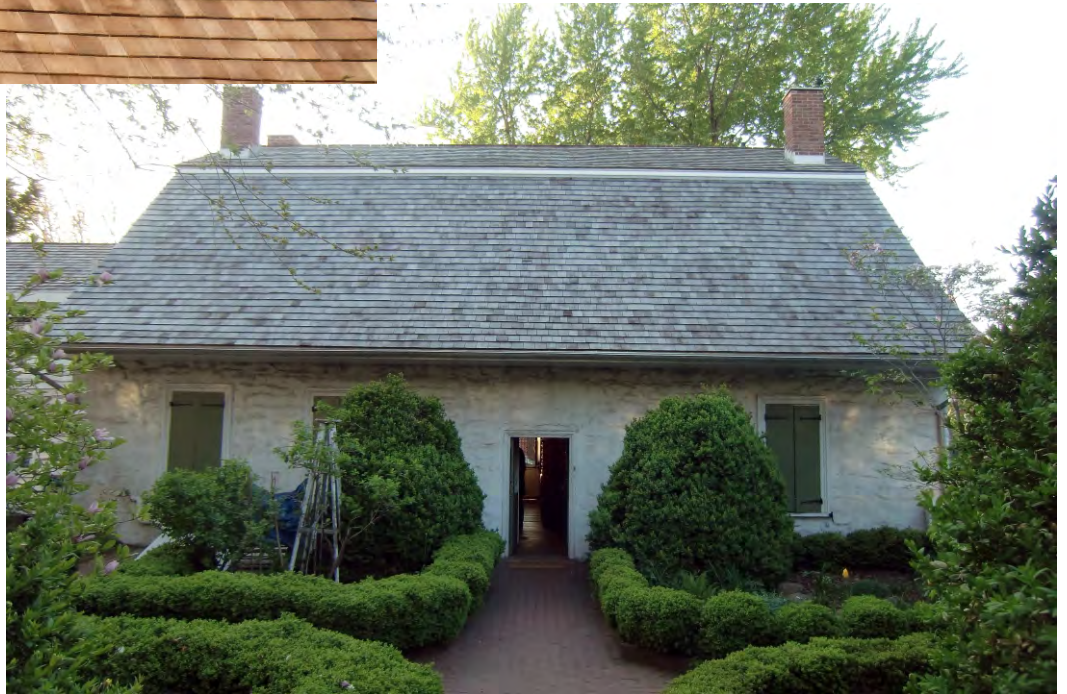
Certigrade®[®], Western Red Cedar 24" Royal Shingles, Number 1 Grade

Top photograph:10/9/14 Bottom photograph: 5/7/15 Natural/Untreated, Northeast United States

The examples shown have no finish, stain or weathering product applied; the photographs all show the natural factors that influence weathering are:

1. Exposure to U/V; the latitude of the structure and micro-climates have an effect on weathering
2. How long is the wood being exposed to the sun (U/V); Position of the wood relative to the angle of the sun, the design of the structure, man-made & natural obstructions
