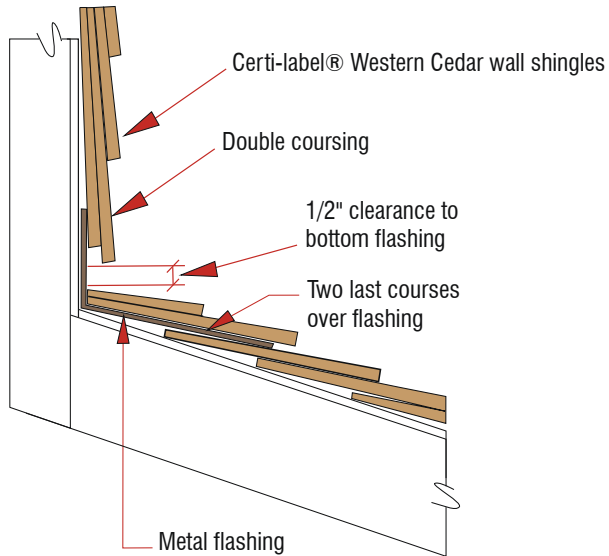
Figure 3a: Flashing

Figures 3a and 3b:

To prevent the wicking of water, which may cause staining, keep a 1/2" clearance between the first course of Certi-label® products from all surfaces below.
